# Manhole Inspection Summary

Manhole # S33A\_\_047MH

**Location** Address: **SIDE OF 530 CENTRE ST**

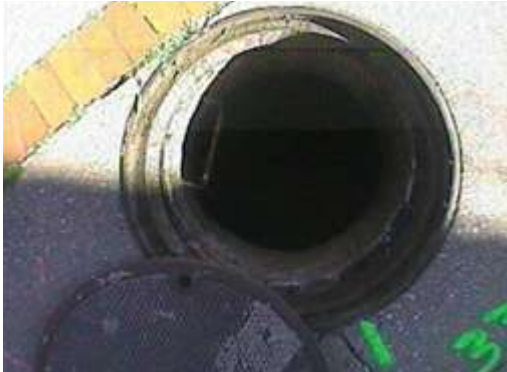
Top View

Offset: **2** (in.)

FRAME OFFSET

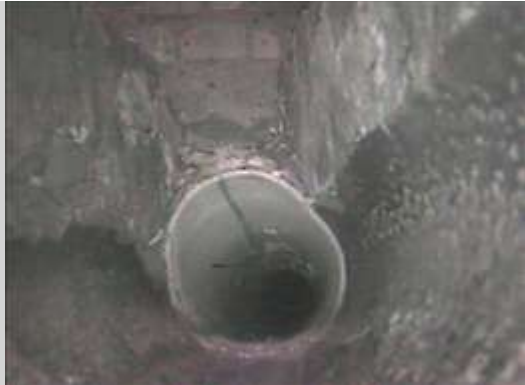
12 O'Clock Outflow

8 in. Circular Gravity Sewer  
Pipe Out @ 12 O'Clock

Pipe Height: (in.) Direct  
Pipe Material: **PVC** ☐ Pipe Lined  
Invert Depth: **12.88** (ft.) Flow Characteristics: **Slow**  
Deposits: ☒ None ☐ Mud ☐ Sludge ☐ Debris ☐ Grease  
Silt Depth: (in.) Deposits Extent:  
Infiltration: **None** Pipe Seal Cond: **Cracked**

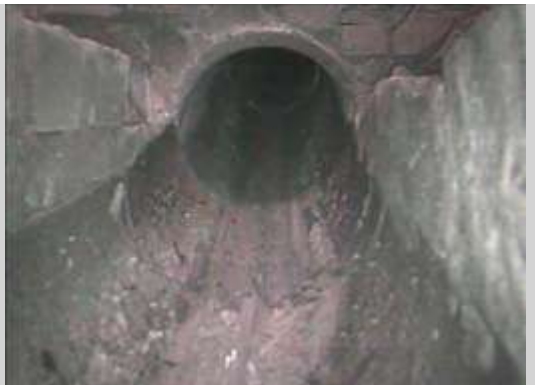
6 O'Clock Inflow

8 in. Circular Gravity Sewer  
Pipe In @ 6 O'Clock

Pipe Height: (in.) Direct  
Pipe Material: **Clay** ☐ Pipe Lined  
Invert Depth: **12.19** (ft.) Flow Characteristics: **Slow**  
Deposits: ☒ None ☐ Mud ☐ Sludge ☐ Debris ☐ Grease  
Silt Depth: (in.) Deposits Extent:  
Infiltration: **None** Pipe Seal Cond: **Sound**
